**Downslope movement of trees and unconsolidated sediment at
Deer Run Heights in Jeffersonville, Vermont**

Prepared By:
Jason Cairelli
Johnson State College
14-May-08

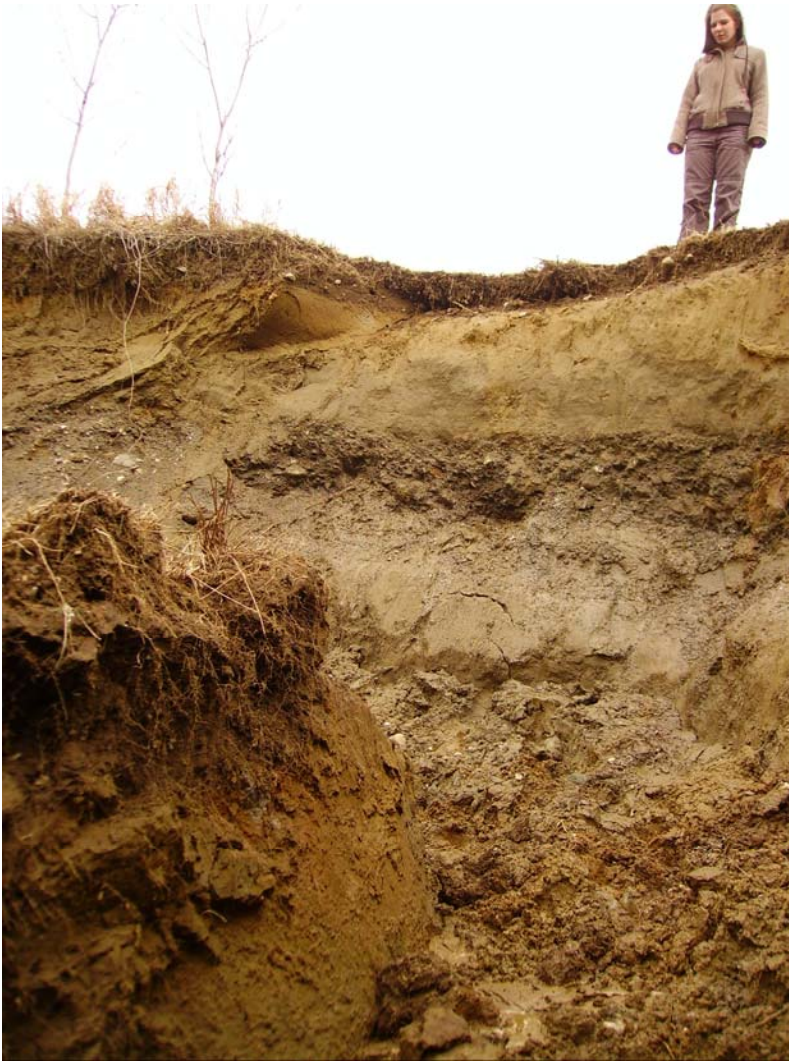
Figure 2. Layered Sediment Near Stake 15

There are several factors attributing to the occurrence of landslides on Deer Run Heights. One is the materials that make up the ridge. The top horizon consists of top soil and extends four inches down. From four to 30 centimeters is fine sand. Between 30 and 90 centimeters is a conglomeratic layer consisting of sand and rocks ranging from pebble size to the entire width of the layer, 30 centimeters. Below this from 90 to 120 centimeters is a fine silt layer. The next layer of the soil profile that was able to be

observed is clay. This can be seen in Figure 2. When precipitation or snowmelt occurs the water is able to infiltrate the soil profile and percolate down until the clay layer is reached. The clay forces the water to change direction and flow parallel to the layer. This causes the top of the clay layer and the silt layer to become saturated with water. When the clay becomes saturated with water it becomes slippery (Montgomery, 2006) making the sand prone to sliding off it. This would not be such a concern on

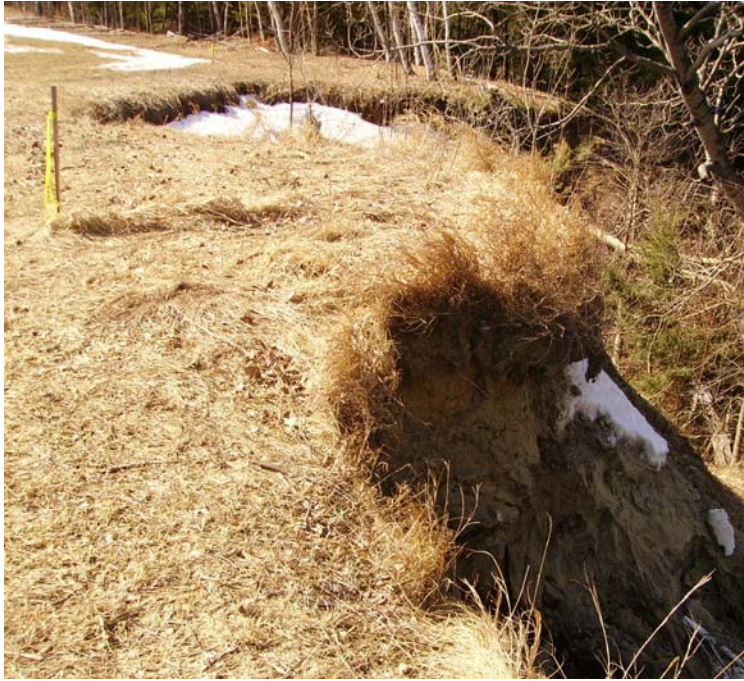
Figure 3. Before Slide, Stake 15 Behind Cambridge Elementary 6-Apr-08

The rate of cutback was measured by Michaela Forsberg using rebar stakes as reference points for the period between 23-Aug-2006 and 20, Apr-2007. The distance from the stake to the beginning of the slope was measured. Two additional measurements were taken at 30 degrees on either side of the initial measurement. The average of the three measurements provided the recorded distance. A total of 19 stakes were placed along the ridge to be used for this purpose. These measurements were continued beginning on 13-Nov-2007 and ending 27-Apr-2008 (Appendix A). The rate of cutback is found by comparing old measurements to more recent ones. When the measurements reveal cutback it shows that sediment had moved from the top of the slope downhill. Figure 3 shows the undercut gully behind Cambridge Elementary near stake 15 on 4-April-2008 (left) and again on 12-April-2008 (right) after the gully experienced 100 meters² of cutback.

The gully has been monitored since August 2006 by Michaela Forsberg and has continued to be monitored since. The gully is located along stakes 13-19 and has severely undercut the ridge along these stakes (Forsberg, 2007). A slide in this area was noticed in this area on April 6, 2008 (Figures 3 and 4) just in front of stake 15. The slide included a portion of the undercut bank at the top of the gully. The slide displaced a small amount of material that remained intact. It was displaced by about two meters. By April 12 the small slide in front of stake 15 had increased to include an estimated 100 cubic meters of sediment. A large portion of this slide consisted of an intact piece of sediment that had been the undercut portion of the gully. After the slide occurred the gully was no longer undercut and had vertical sides. This slide flowed straight towards the school at a bearing of 270°. This slide is insignificant in material size and displacement but serves as a reminder of the instability of the slope and the threat of damage to the elementary school.

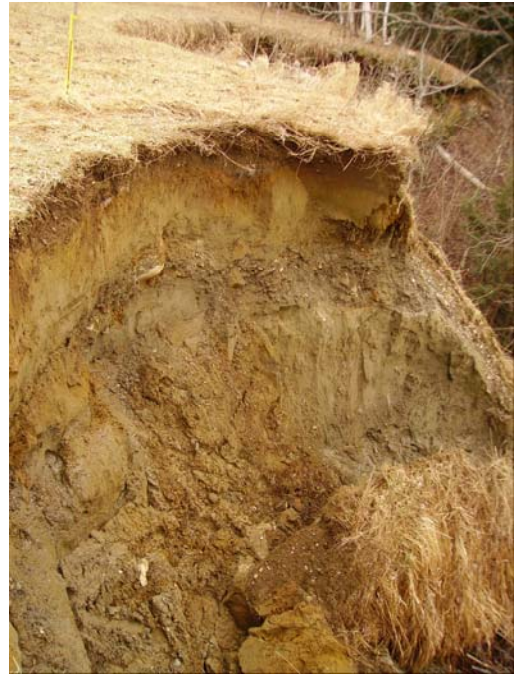
Figure 4. After Slide 12-Apr-08

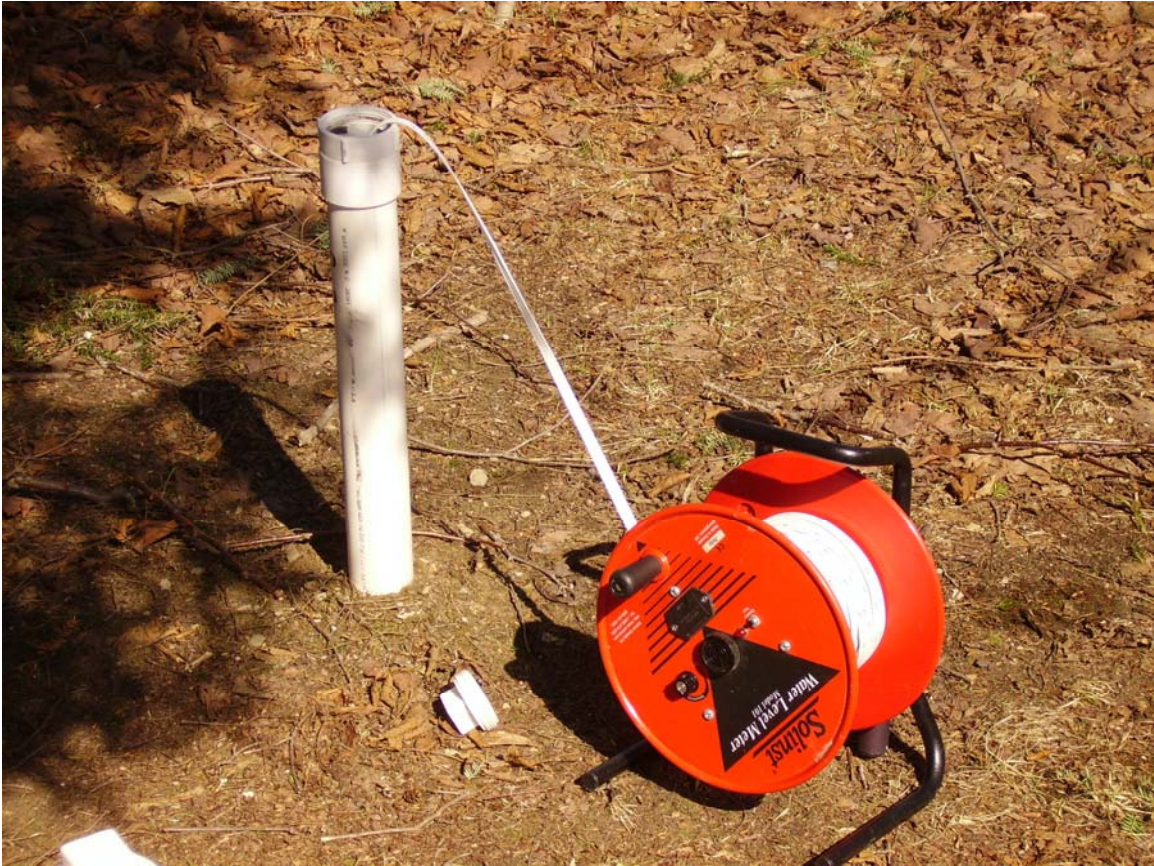
Figure 5. Solinst Water Level Meter in use at B1

Four observation wells have been drilled by Wilcox Environmental Services on the Farara's property to measure the distance down to the water table. The First well (B1) is located on the northeast corner of the property B2-4 are located about 20 meters west. A Solinst Water Level Meter, Model 101 has been used daily to monitor the height of the water table in each of the wells (Figure 5). The portion of the device that senses water is lowered into the well until the instrument beeps signifying it has reached water. The sensor is attached to a tape measure that is mounted on the device. The distance from the top of the water table to the top of the PVC pipe was recorded. Some days were not recorded as a result of being away from the area or the well caps being frozen.

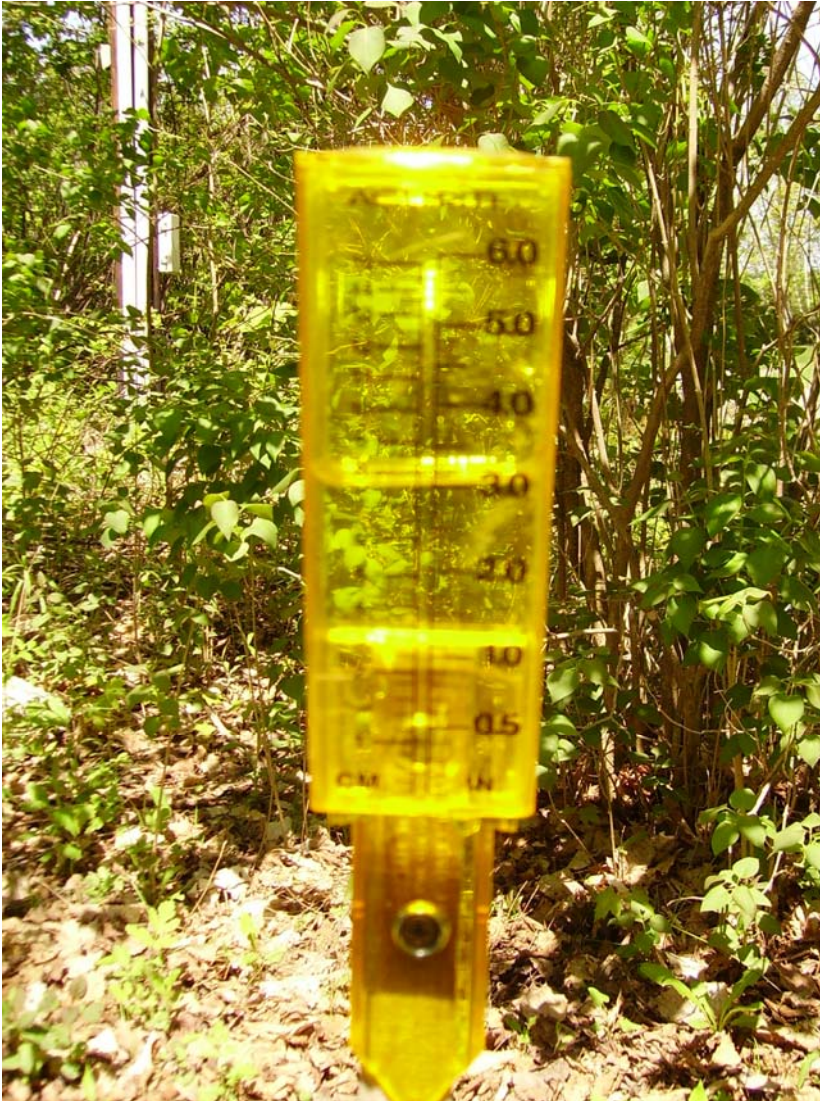
Figure 6. Rain Gauge 1 (RG1) Located on the Farara Property

Two rain gauges have been placed on Deer Run Heights and are being monitored daily (Figure 6). They are in close proximity to B1. One is slightly northeast of the first drill hole the other is about 30 meters north. The purpose of these rain gauges is to correlate precipitation events with changes in the water table and to potentially establish a lag time between the two. Readings are taken after a precipitation event from the side of the gauges where

precipitation depth is marked in centimeters and inches. After each reading the rain gauges are emptied. These measurements were taken only in the fall because of freezing in the winter. The rain gauges could not accurately collect snowfall. During the winter, ice buildup cracked the rain gauges. Since they could no longer hold water measurements were stopped.

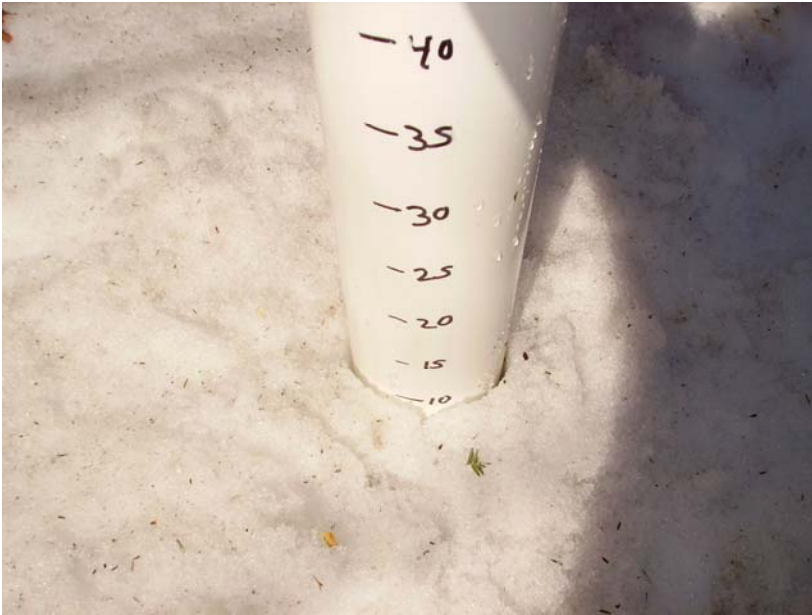
Figure 7. Snow Core Sampler In Use

Snow pack prior to spring melt was measured using two methods. Both measurements were taken using a PVC pipe to extract a core sample of the snow (Figure 7). This was done by driving the pipe into the

snow until it reached the ground. Once the ground

was reached the pipe was tilted towards the ground. This allowed the sampler to see beneath the core that was being removed to be sure the ground was reached. If the ground could be seen the end of the coring sampler was covered with a flat surface in order to be transported; the sample was dropped into a bucket. The bucket was weighed and the sample was discarded. Since one gram of water is one cubic centimeter, the amount of water produced by the snow melting could be found. The second method differed because each sample was placed into a plastic bag. The bags were brought inside and allowed to melt. Once melted the volume of water was measured using a graduated cylinder. The snow in the area did not cover the ground everywhere; approximately 65% of the ground was covered with snow. This was taken into consideration when calculating the total snow pack available for aquifer recharge. Bare spots as well as deep snow drifts were present and an effort was made to sample areas where the snow depth was close to average.

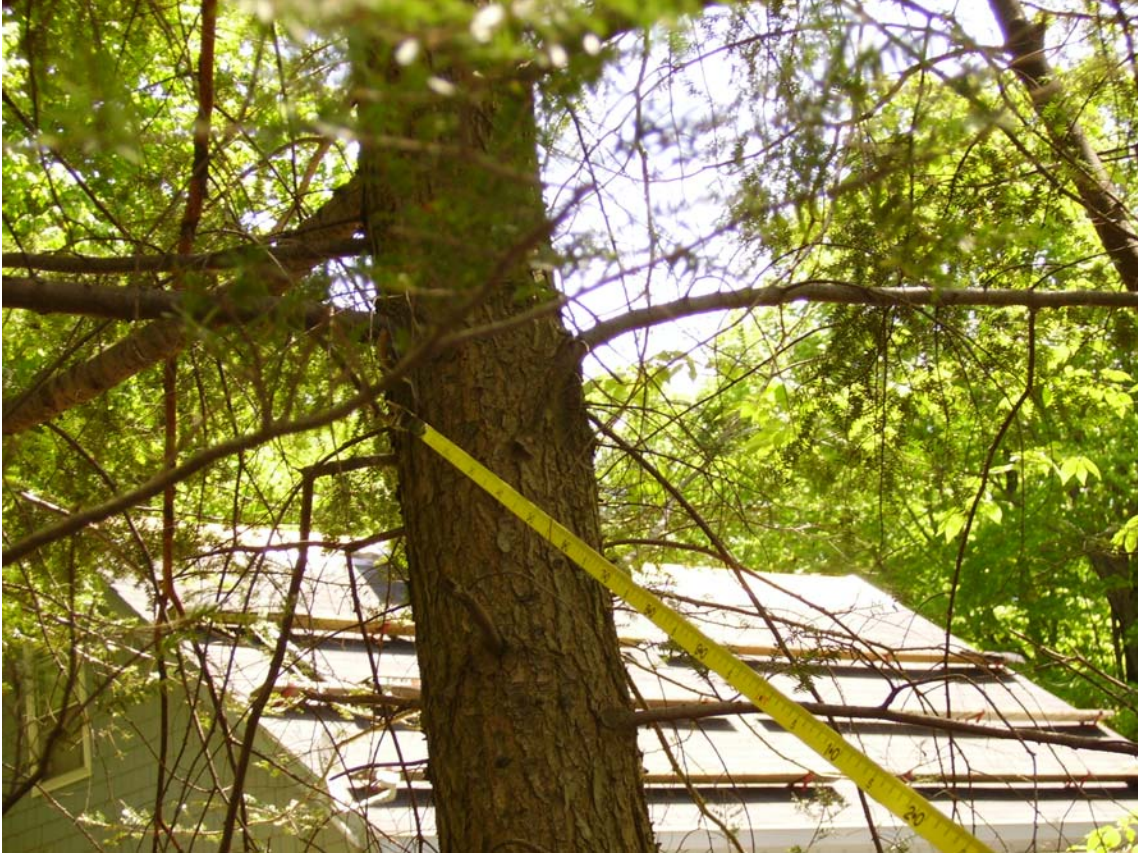
Figure 8. Measuring Distance Between Trees 1 and 2 (T1 and T2)

Four transects descending down the slope to the north were established. Thirty trees were identified in these transects. The distance between a tree up slope and a tree down slope was measured (Figure 8) and recorded. The distance was measured to a given point on each tree marked by a nail and tagged with a number indicating the sequence of the trees in the transects. Any change in the distance between trees indicates movement along the slope. The transects extend from the top of the ridge, west, down slope towards the Brewster River and end at various locations on the toe or bench of the slope. A map was attempted but the tree cover did not allow for the use of a GPS device. The transects all begin on the Farara property at the top of the slope. T1 begins directly behind observation well B2. T2-4 are located to the west.

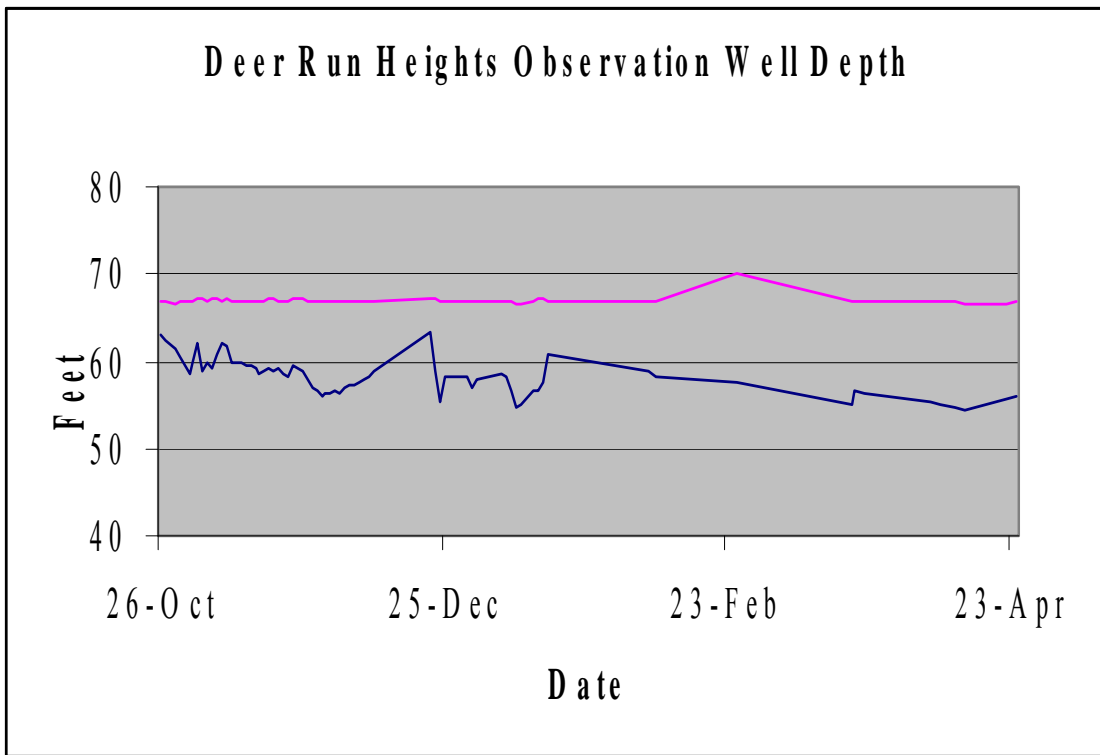
Figure 9. Water Table Height for 26-Oct-07 to 10-Dec-07

The results of the data collected from the observation wells and the rain gauges between 26-Oct-07 and 10-Dec-07 can be seen in Figure 9, page 11, for all results refer to Appendix A. This data shows the variable height of the water table with respect to rain events and seasonal changes. The depth of the water table in the ground was found to vary greatly. In the time of the study the water table height in B1 changed by 8.5 feet. The lowest point in B1 was on 10-Oct-2008 at 62.9 inches and the highest was in the spring on 13-Apr-2008 at 54.4 inches. There is a clear indication that precipitation events raise the water table between two and three days after the storm, and that the water table begins to drop shortly after. The graph shows the entire area gradually losing water as the winter progressed. The water table fluctuates in height with short term recharge events caused by precipitation as well as seasonal changes such as frozen ground in the winter and snowmelt in the spring. The water table is subject to large variation in a short time span suggesting large aquifer recharges can occur suddenly but are most likely in the spring when snowmelt and precipitation recharge the aquifer. Data from the observation wells indicates that during the beginning half of April the water table is at its highest. Water table height and slope instability showed correlation. A slide occurred near stake 15 behind Cambridge Elementary between April 6th and 12th 2007.

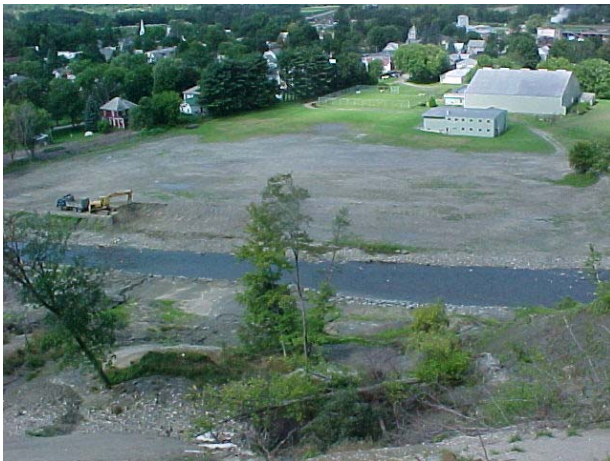
Figure 9. Long Runout of the 1999 Landslide (Nichols, 2001)

The runout length of the 1999 landslides extends 290 m from the bottom of the slope (Figure 9., Nichols, 2001). Runout length and the orientation of the debris suggest that the landslide movement was partially a debris flow (Nichols, 2001). A debris flow or debris avalanche is when the material transported is not coherent and moves in a chaotic disorganized fashion (Montgomery, 2006). The second slide most likely exhibited these characteristics (Nichols, 2001). This type of flow was responsible for the extremely long runout produced by the slides.
