# Using GIS, Lidar, and Drone Imagery to Visually Represent Landslide Cutback at Deer Run Heights in Jeffersonville, VT

Lillian Kolbenson

Department of Environmental and Health Sciences at Northern Vermont University-Johnson

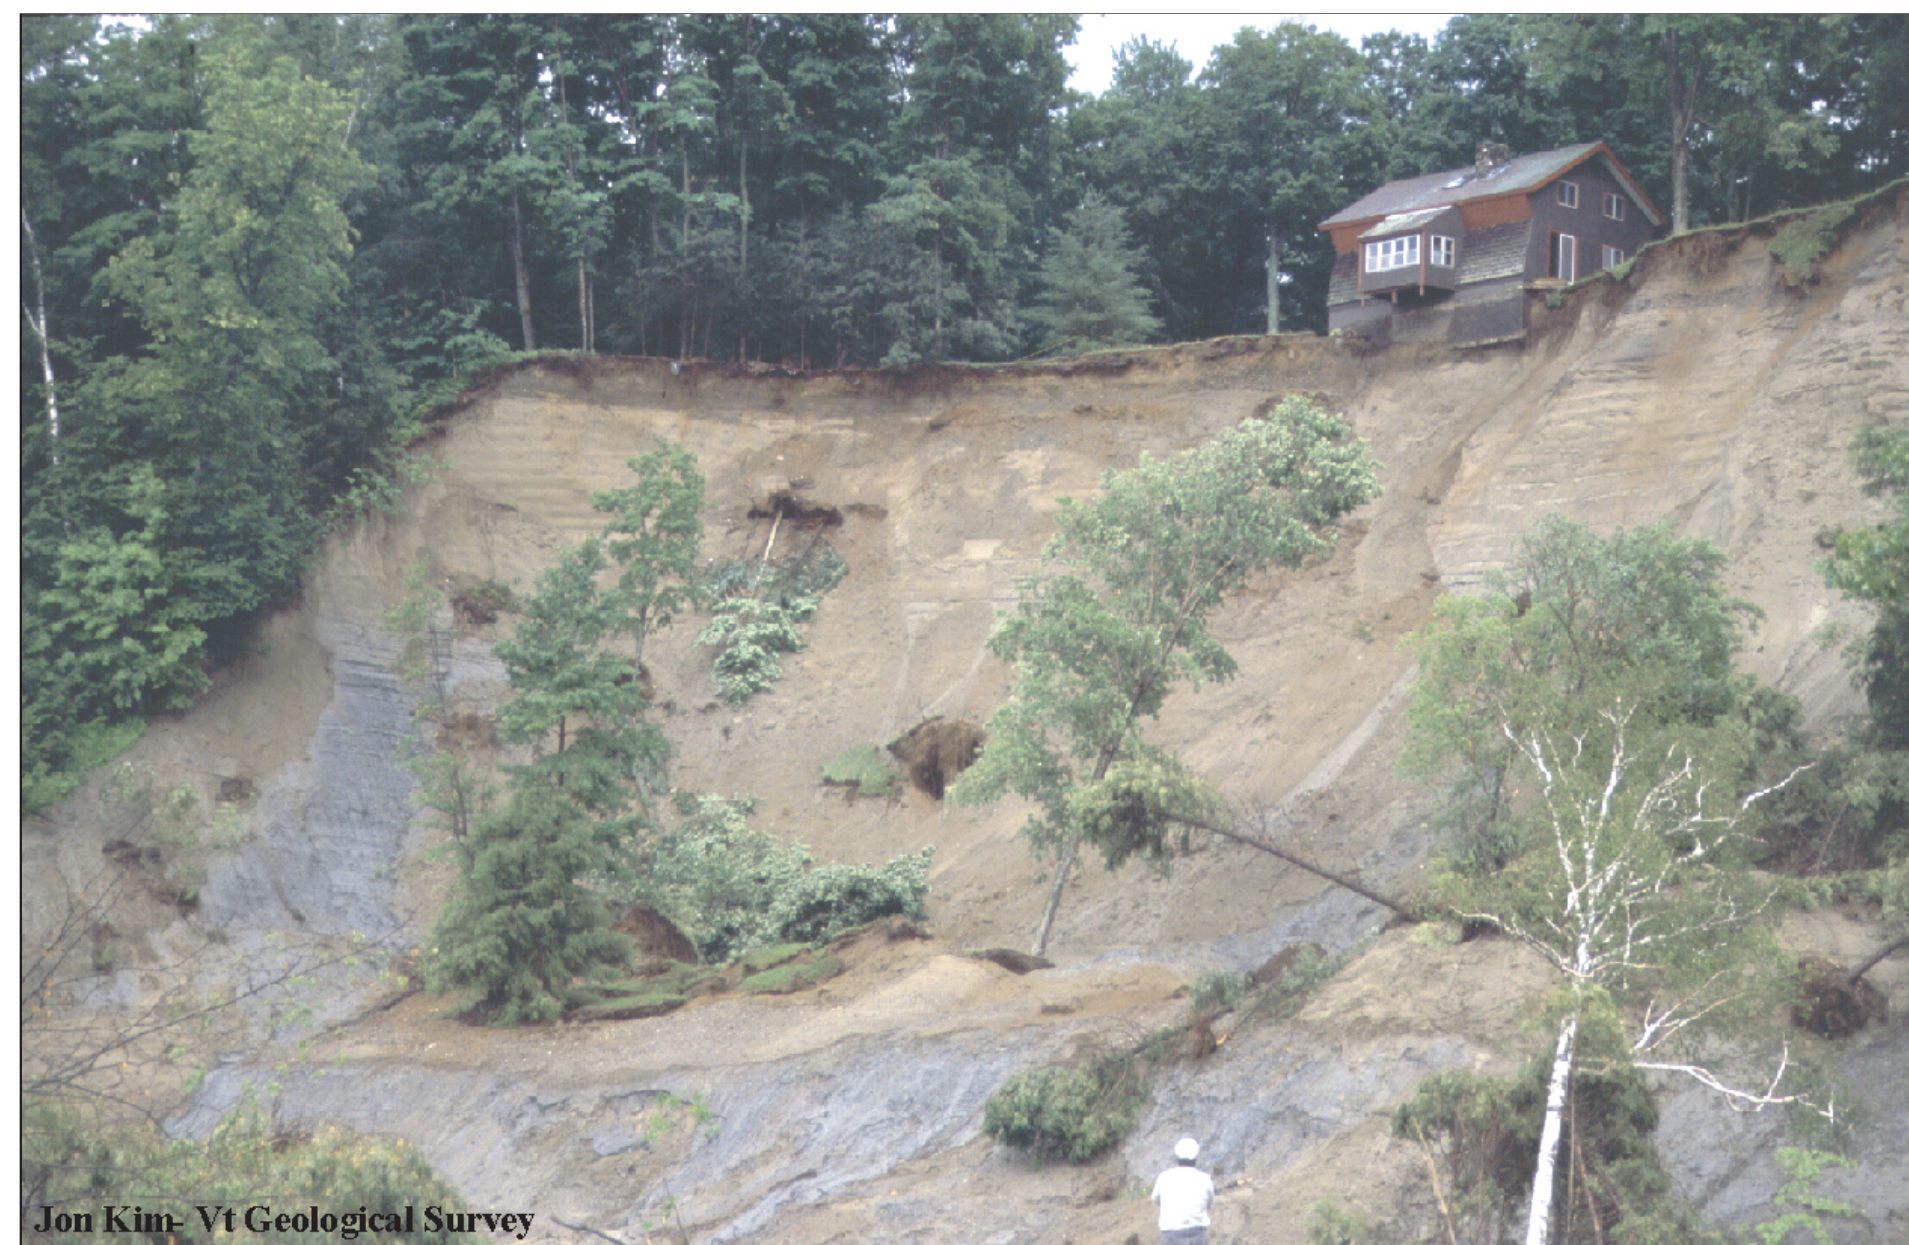
Figure 1. Photograph of the landslide site at DRH following the 1999 event (VGS 2018).

The most recent major landslide event at Deer Run Heights (DRH) located in Jeffersonville, VT occurred in 1999 (VGS, 2018; Figure 1). It left one home overhanging the ridgeline and threatened other residences with potential damage, including an elementary school and homes at the bottom of the slope (VGS, 2018). The geological factors that caused this event included poorly consolidated rock and soil materials, high levels of water in the soil, and erosion due to the river beside this site (VGS, 2018). Monitoring of this site includes using time domain reflectometry to identify fluctuations of strain with depth, soil moisture logging, depth to the water table, and cutback measurements along the ridge. Cutback measurements, which are the focus of this research, were collected in Aug 2006, Oct 2006, Apr 2007, Jun 2013, Aug 2016, and Sep 2018. The ridgeline of the landslide gulley complexes was measured using nineteen GPS-identified locations that are marked by stakes to help capture the rate of erosion at active areas by the distance from the stakes to the ridgeline.

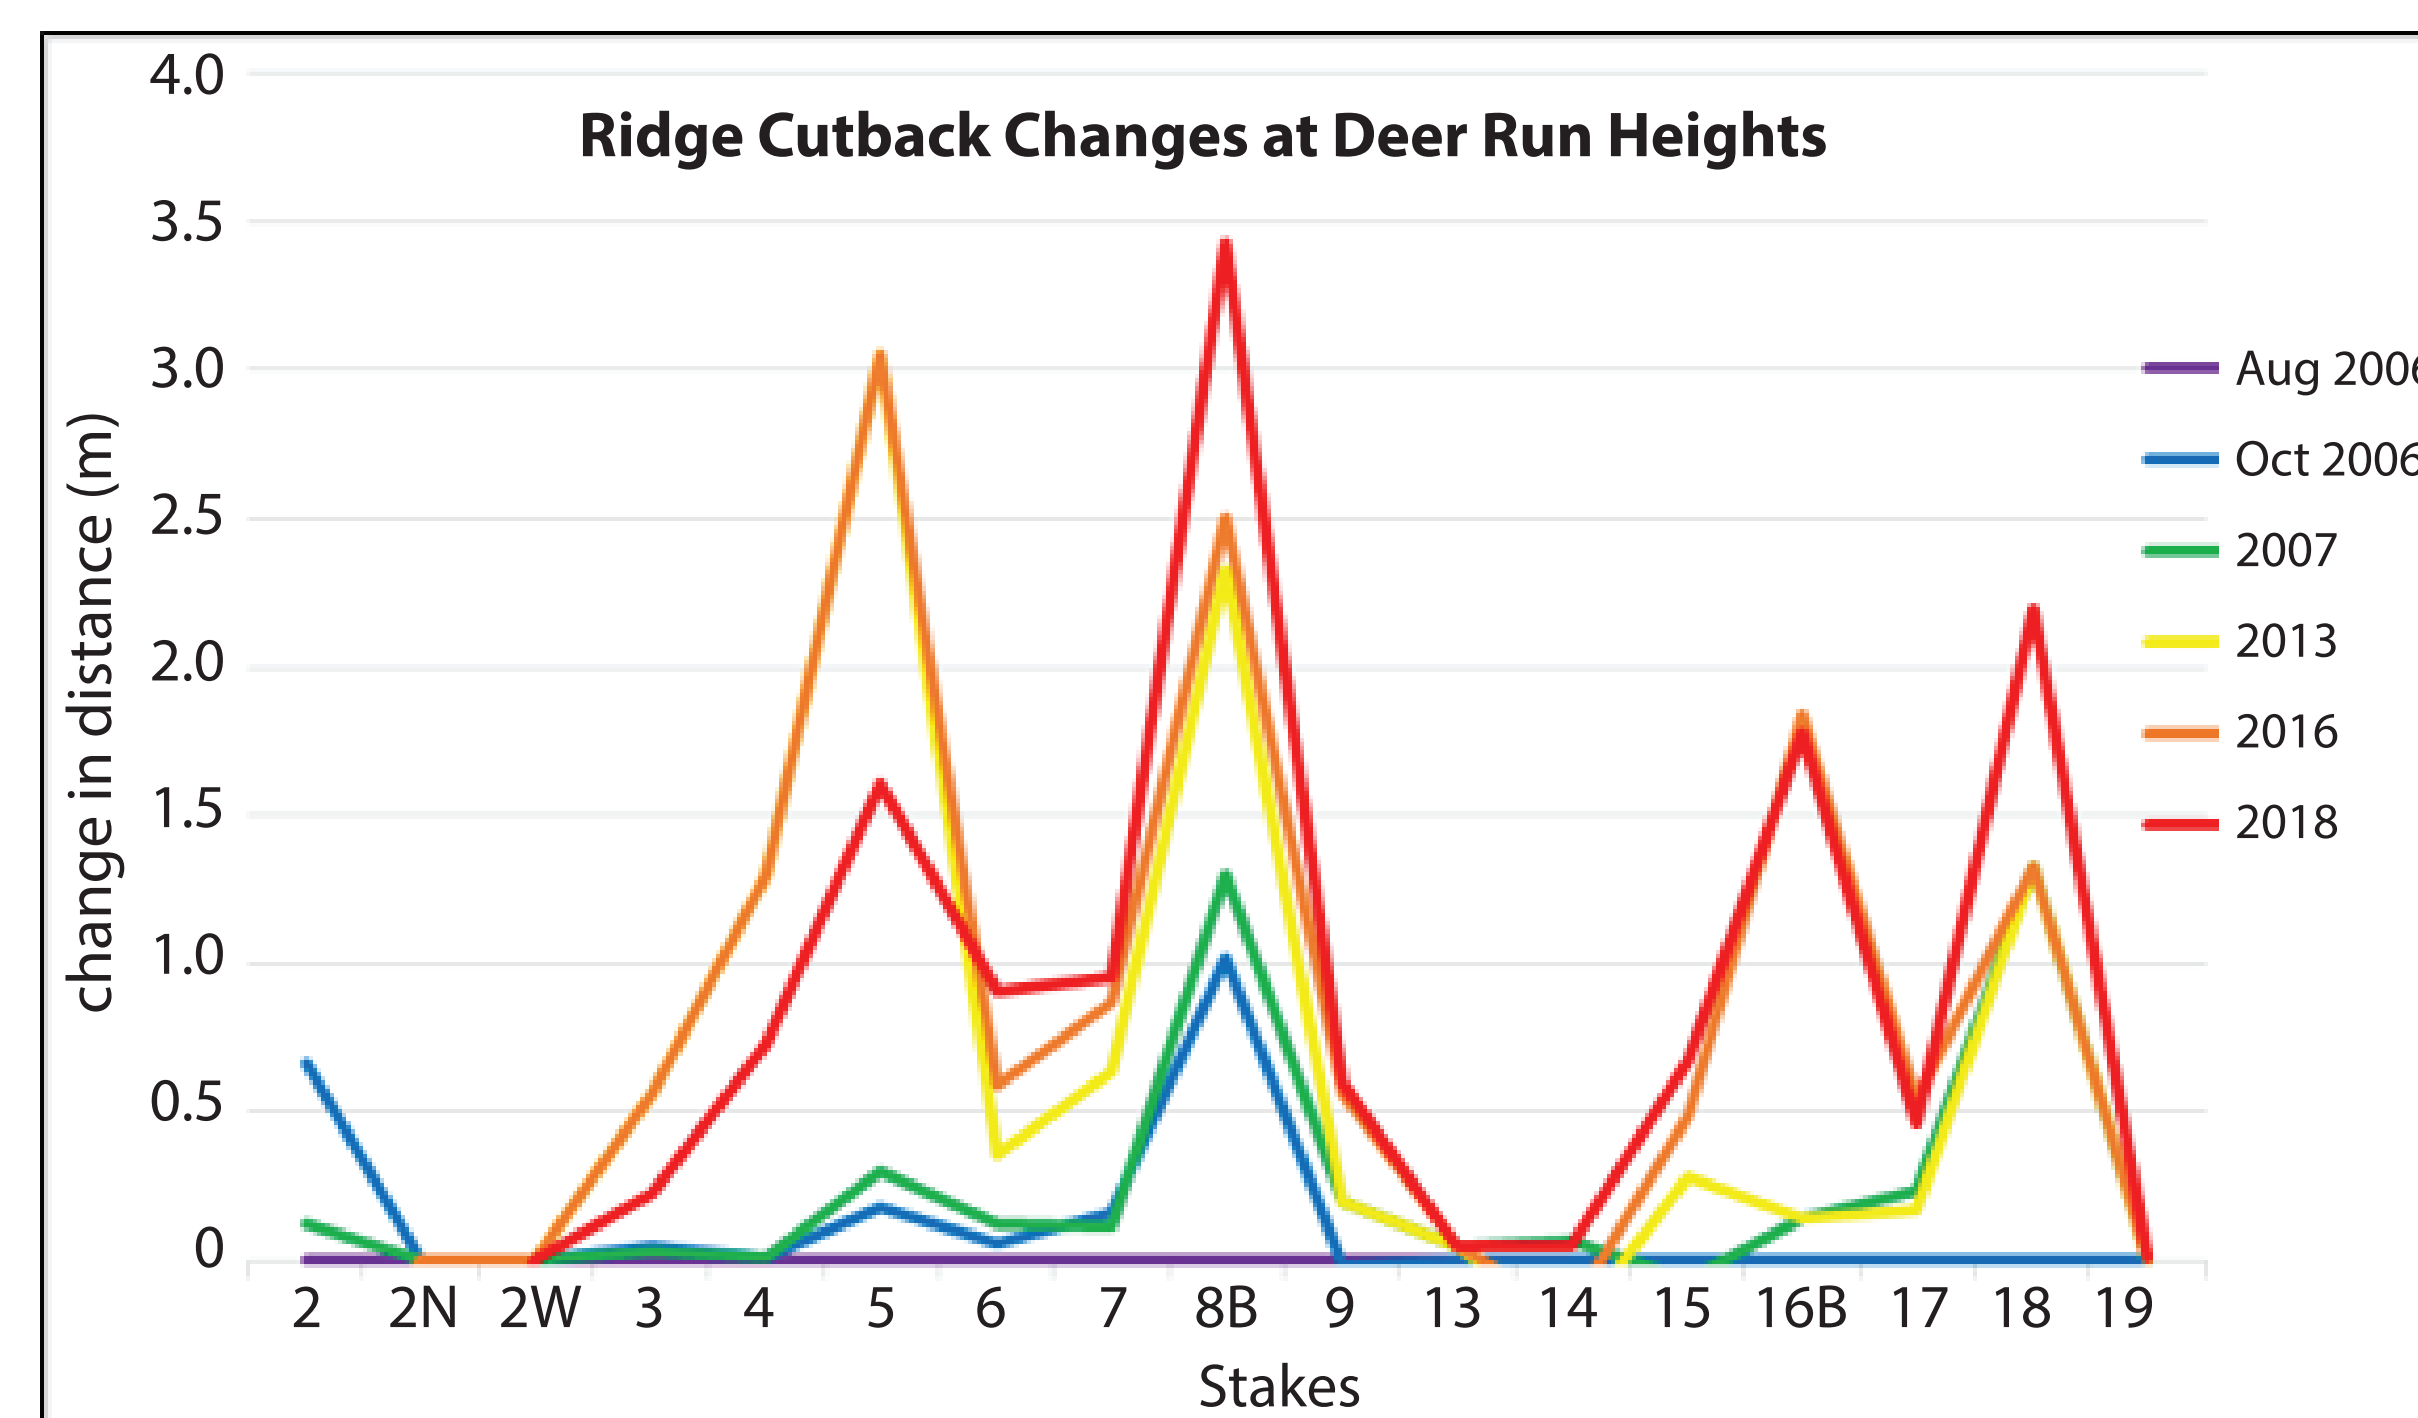
Figure 4. Change in ridgeline position at each stake for every collection year.

The northern region had an average change of 1.34 m, the central region had an average difference of 0.23 m, and the southern region had an average change of 0.81 m. On average, this site had a change of 1.48 m, which equates to approximately 0.12 m per year over the 12 years observed. The greatest changes, based on stake location, of the ridgeline over the study area occurred at 8B, 16B and 18. Stake 8B showed a change of 3.43 m. Despite this, the other stakes in the central region were no as extreme comparatively, stake 6 had a change of 0.91 m, stake 7 had a change of 0.96 m, and stake 9 had a change of 0.61 m. The southern region including the stakes 16B and 18 is quite active. In this area the smallest changes in the ridgeline this area was around stakes 13 and 14 (Figure 4).

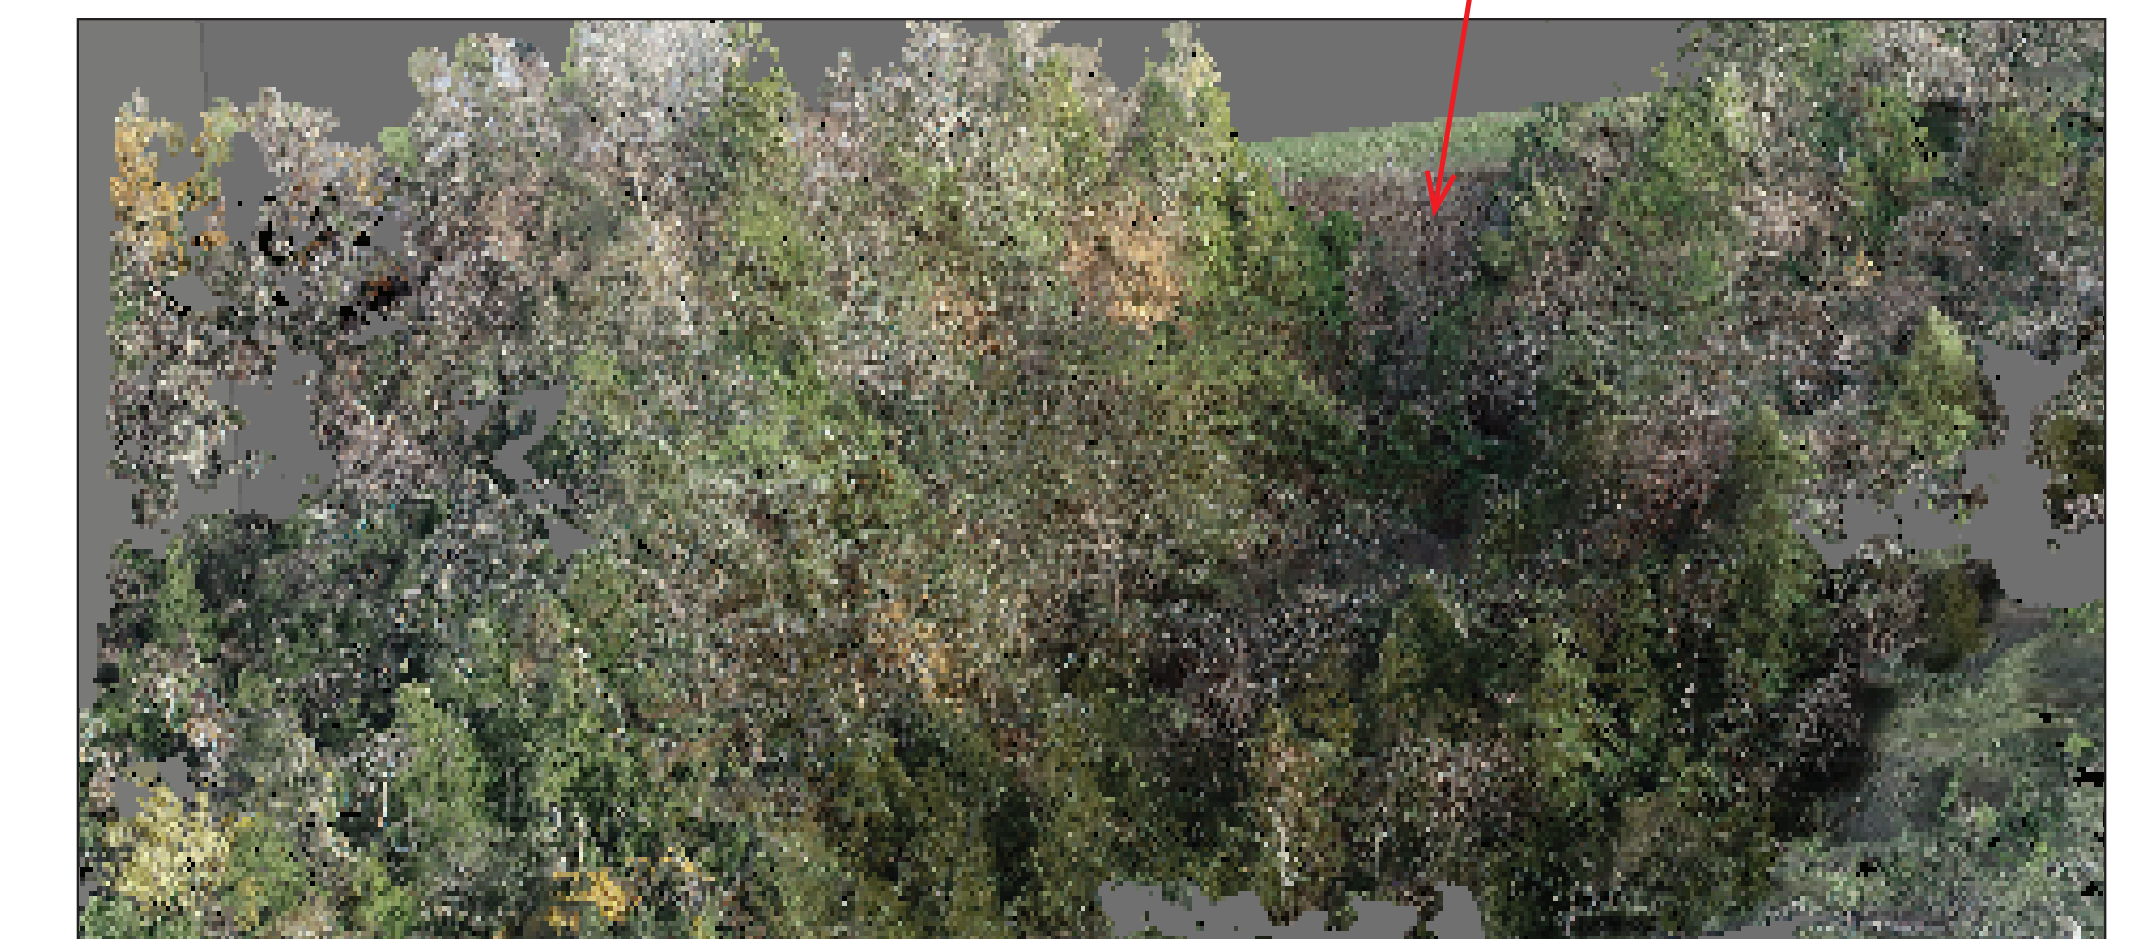
Figure 6. A 3D model of the active southern region of DRH, near stake 16B, located above the parking lot of Cambridge Elementary School.

Future drone flights of the landslide site should focus on the stake locations themselves, rather than capturing the grand picture (Figures 5 and 6). This will allow for use in QT Modeler, provide better location information, and allow for the calculation of volume loss of material at the landslide site. Additionally, there is also a possibility for drone mapping the central region and building a 3D model, yet it is difficult given the amount of vegetation in this area. The GIS maps and associated video (Kolbenson 2018) demonstrate the change overtime. The 3D model offers multiple formats and focus areas of the landslide site to explore and describe the current state. In future years, this model can be compared to future measurements and updated 3D models in order to determine cutback along the ridgeline. Similarly, the GIS maps can be used to compare future measurements and new data points can be added to the software. The potential for damage on the local community reiterates the importance of continued surveillance of this area.
